**CLEAN WATER ACT COMPLIANCE INSPECTION
U.S. ENVIRONMENTAL PROTECTION AGENCY, REGION 5**

Legend Farms Dairy, LLC

Date of Inspection: April 20, 2017 - April 21, 2017

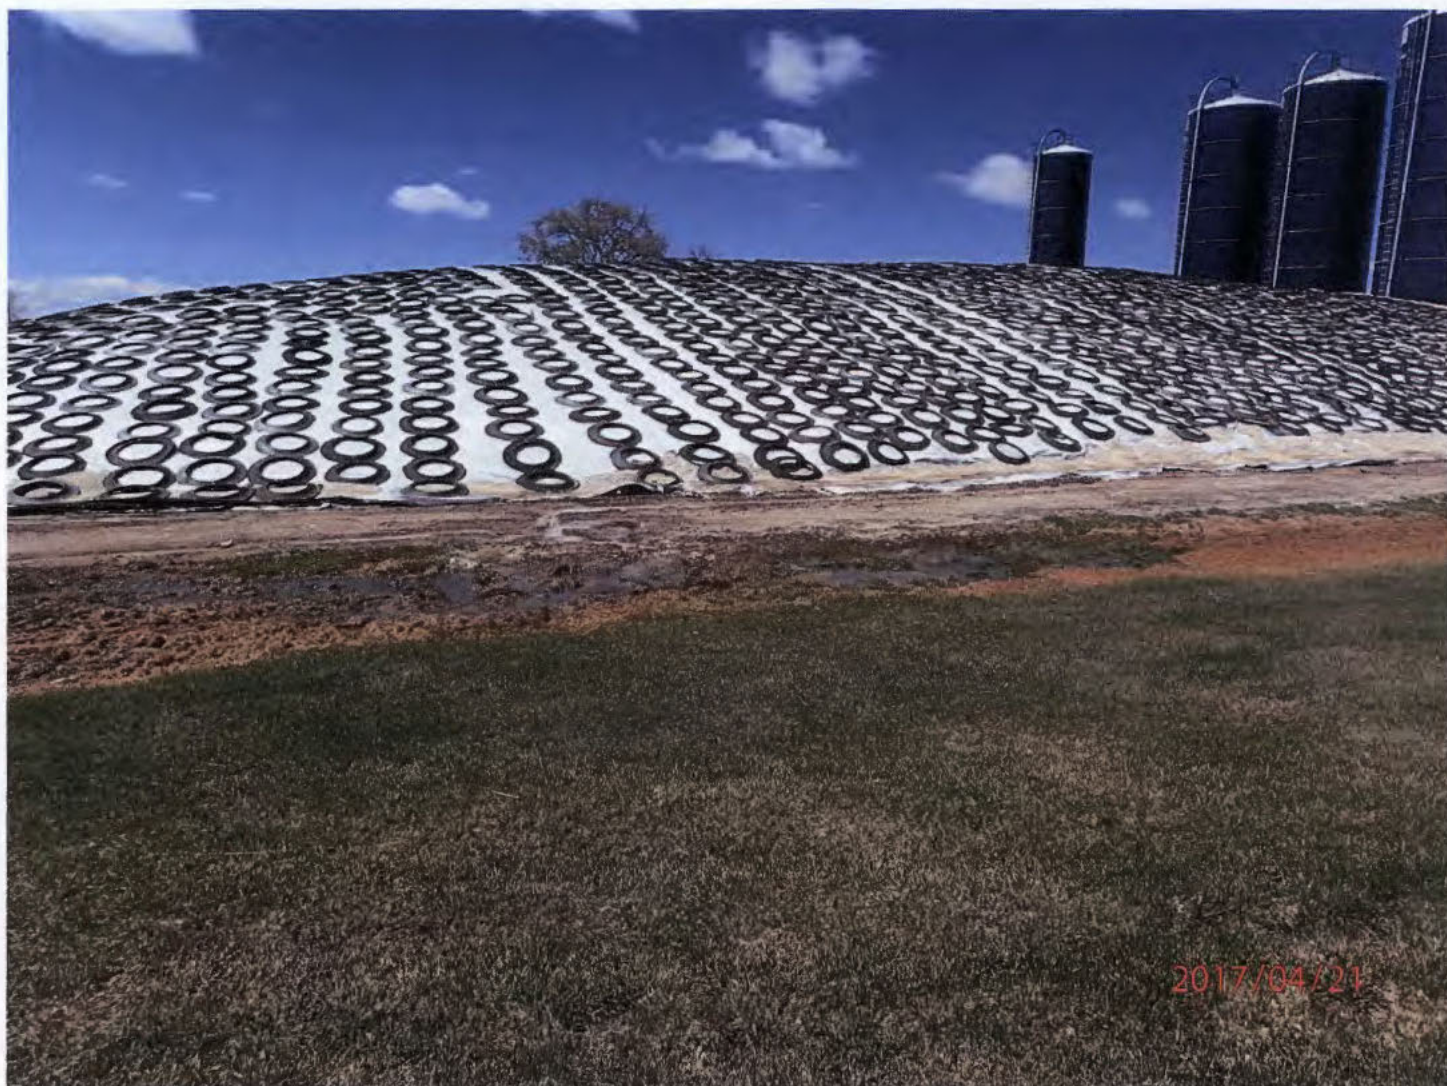
Photo: P4210120

Description: EPA observed feed and surface water (process wastewater) discharging off of the silage pad into the roadside ditch west of Lilac Lane.

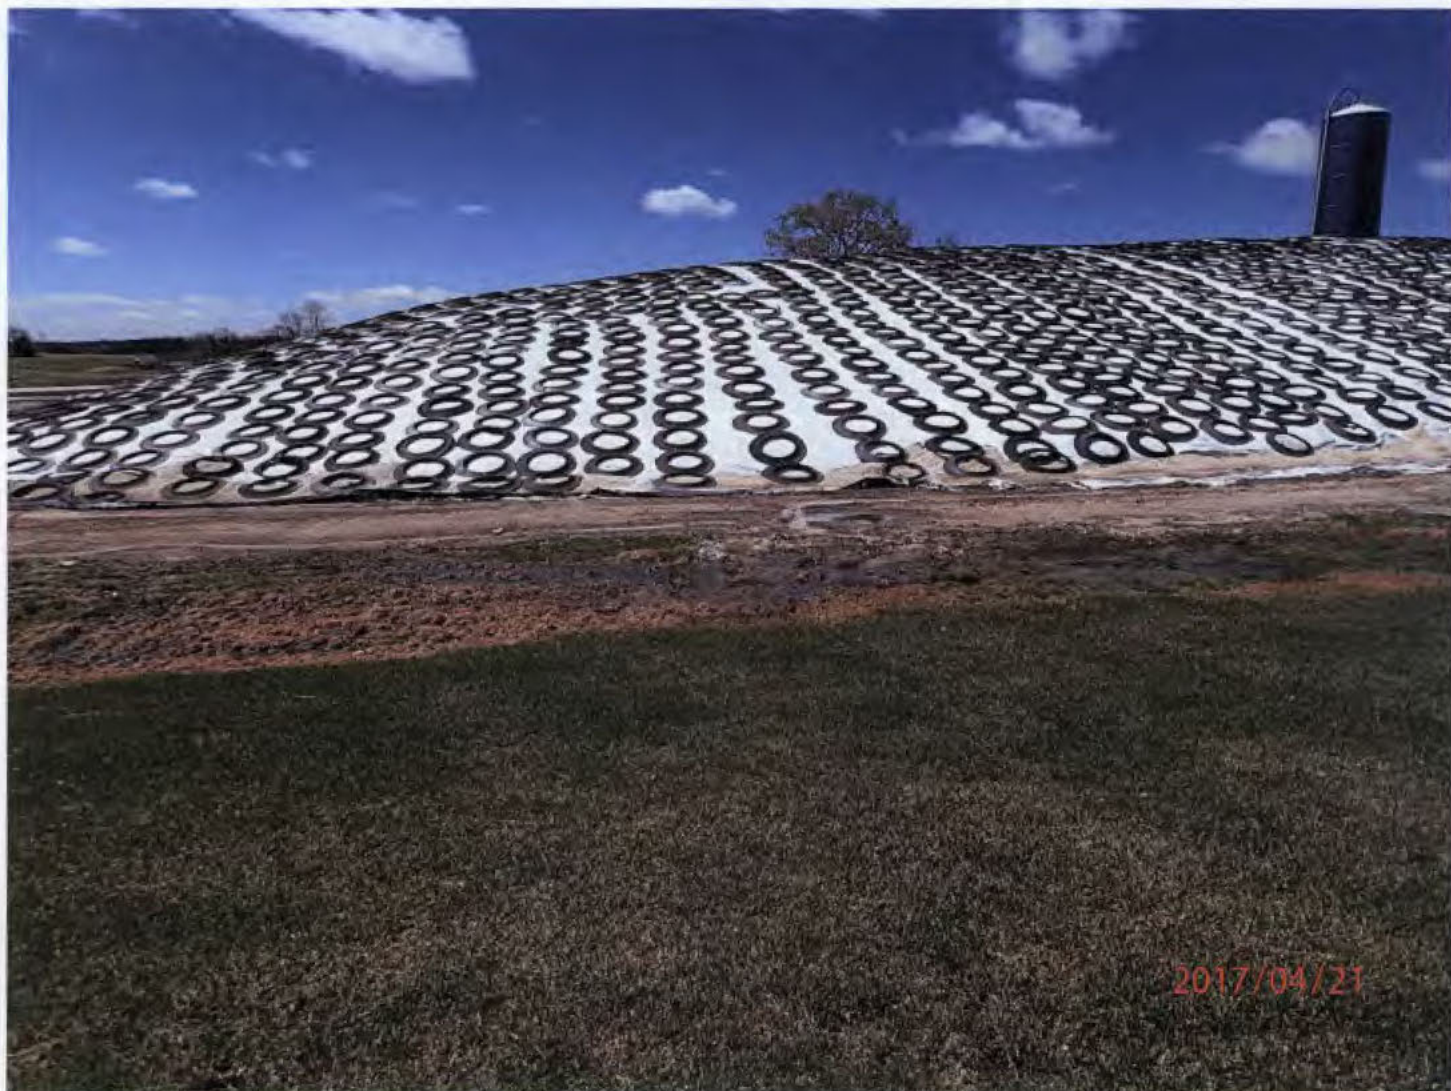
Photo: P4210121

Description: EPA observed feed and surface water (process wastewater) discharging off of the silage pad into the roadside ditch west of Lilac Lane.

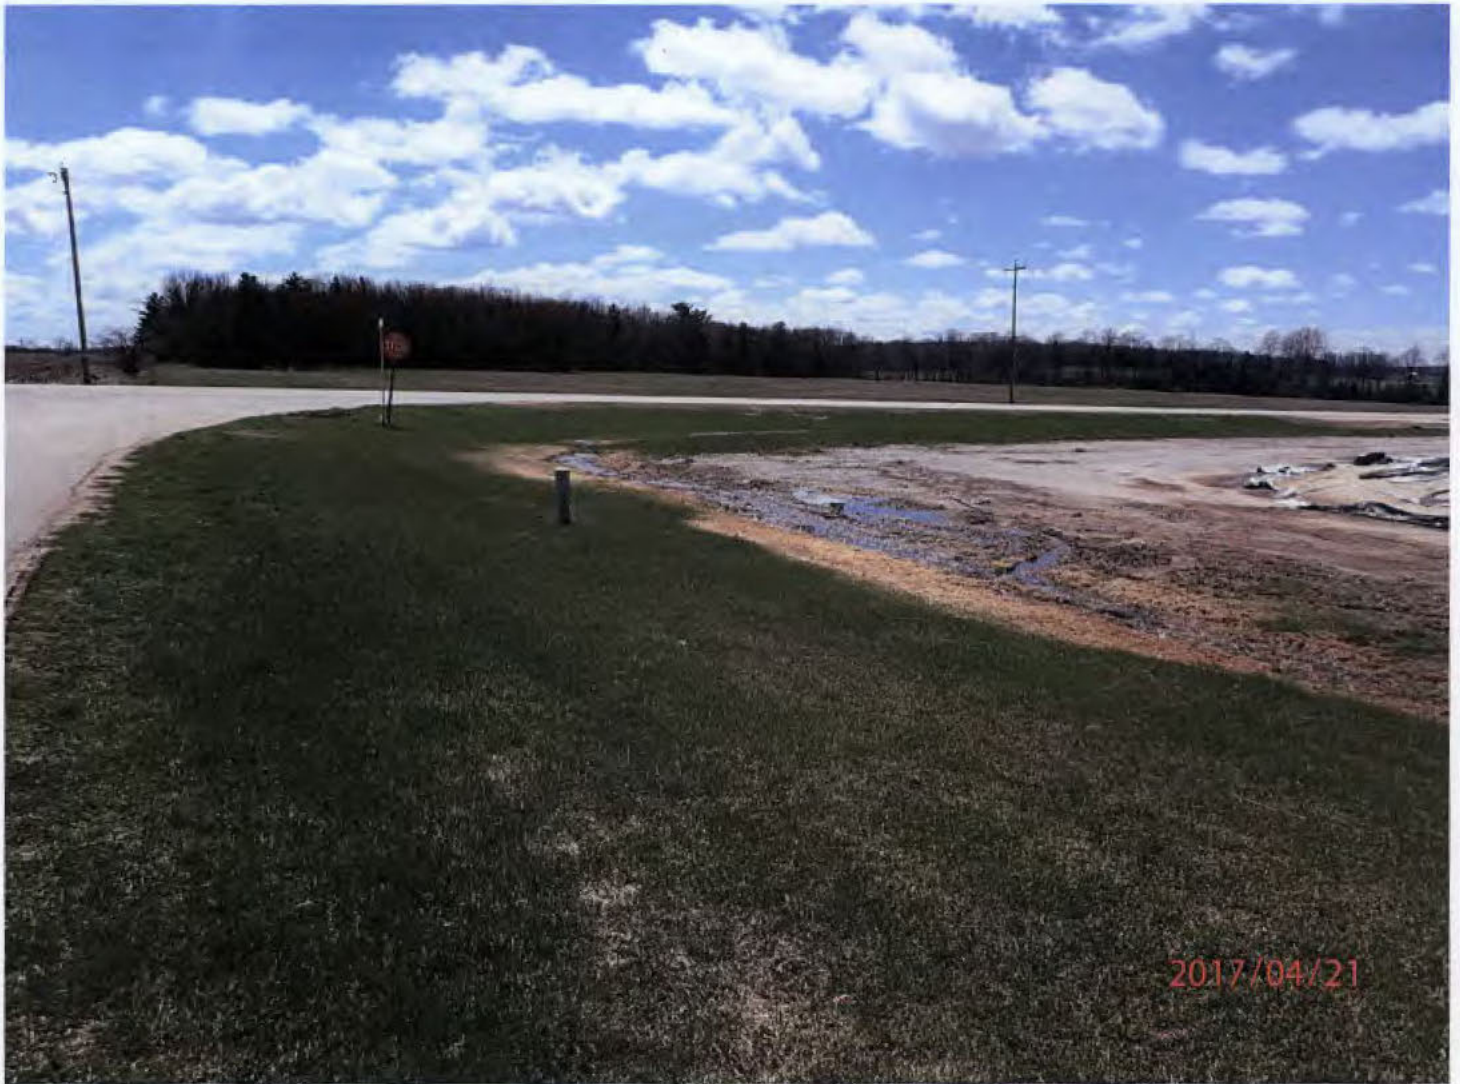
Photo: P4210122

Description: EPA observed process wastewater feed and surface water (process wastewater) discharging off of the east side of Legend Farms Dairy, LLC's silage pad into the roadside ditch west of Lilac Lane. The process wastewater flowed south around the bend into the roadside ditch on the north side of County Road F.

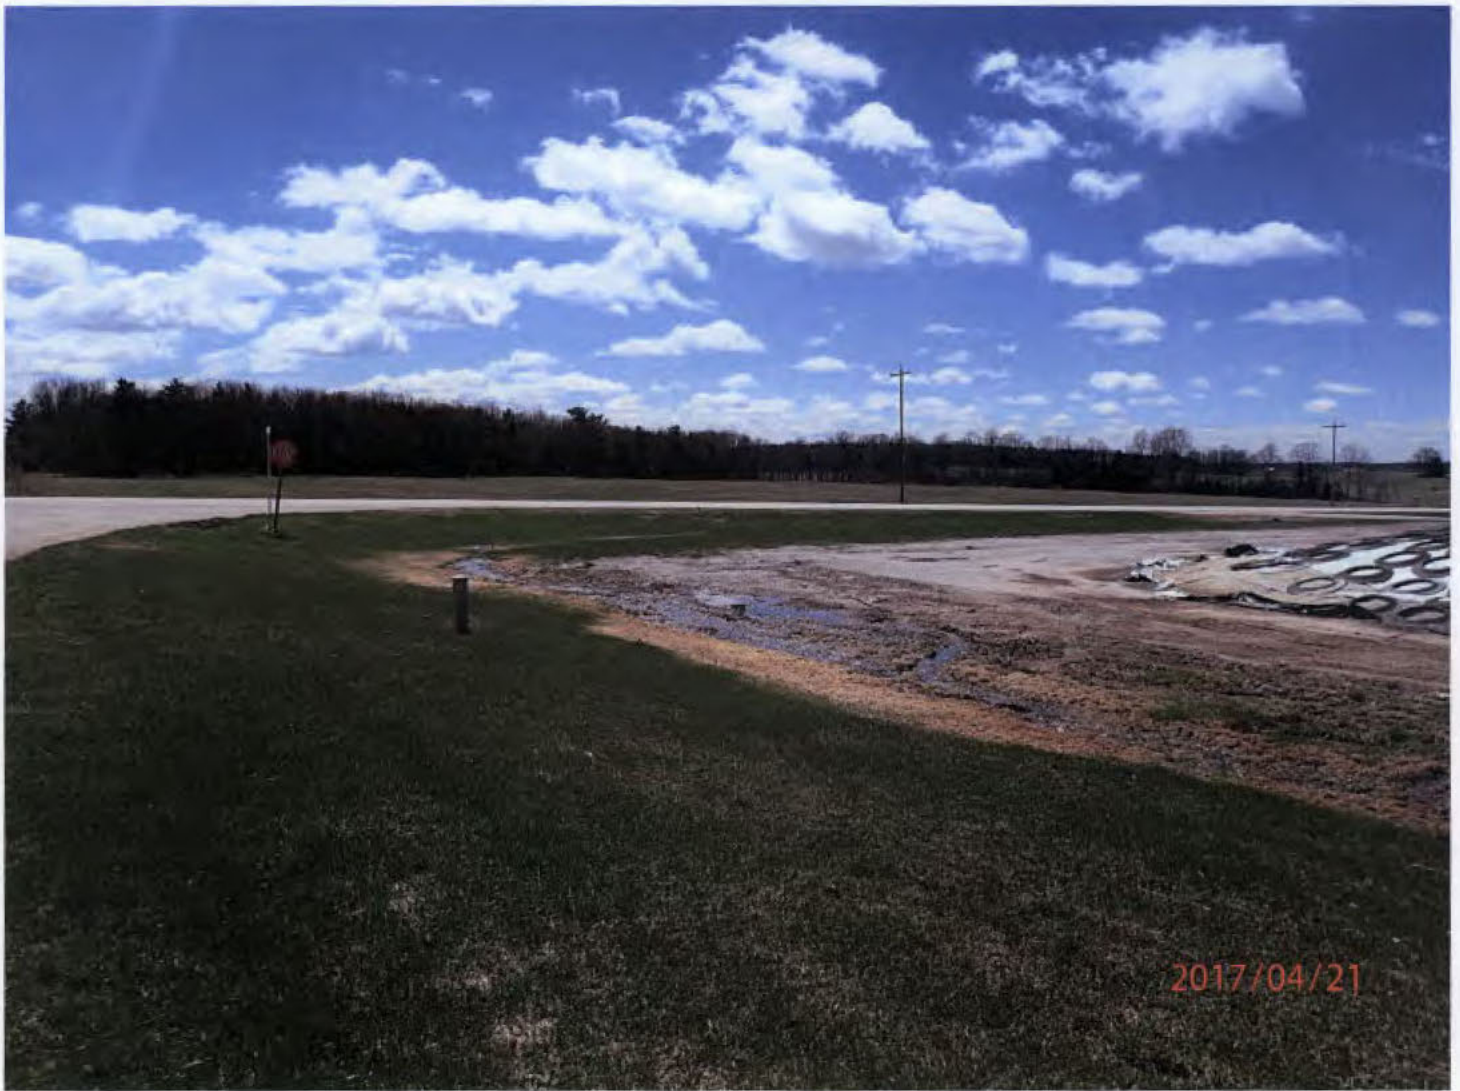
Photo: P4210123

Description: EPA observed process wastewater feed and surface water (process wastewater) discharging off of the east side of Legend Farms Dairy, LLC's silage pad into the roadside ditch west of Lilac Lane. The process wastewater flowed south around the bend into the roadside ditch on the north side of County Road F.

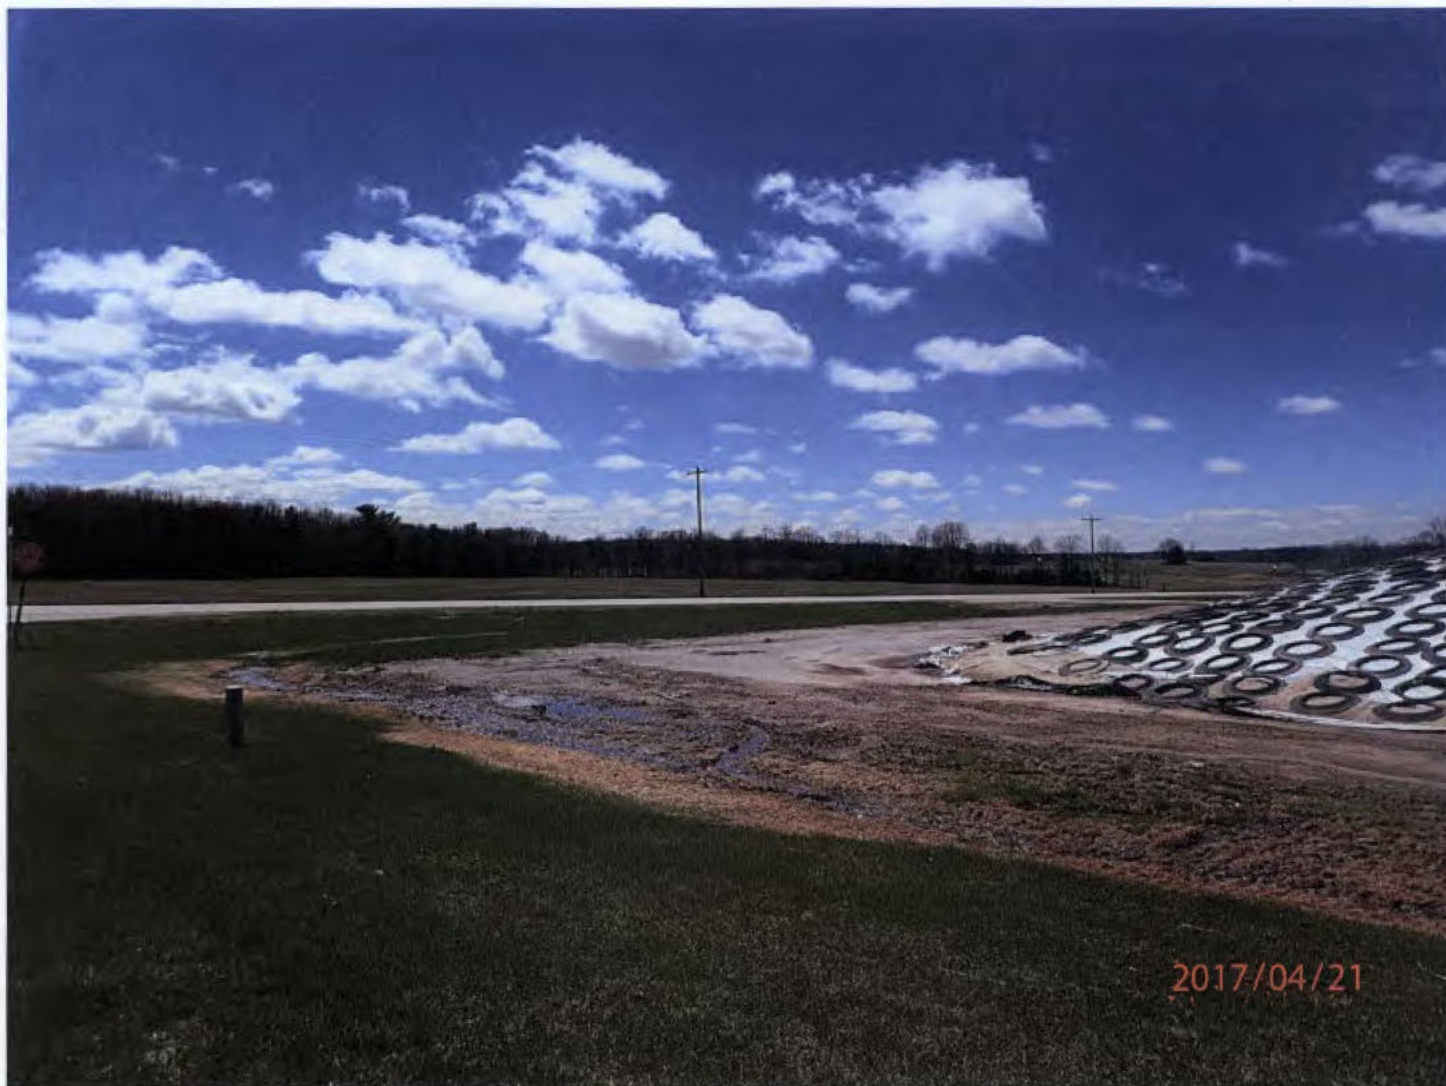
Photo: P4210124

Description: EPA observed process wastewater feed and surface water (process wastewater) discharging off of the east side of Legend Farms Dairy, LLC's silage pad into the roadside ditch west of Lilac Lane. The process wastewater flowed south around the bend into the roadside ditch on the north side of County Road F.

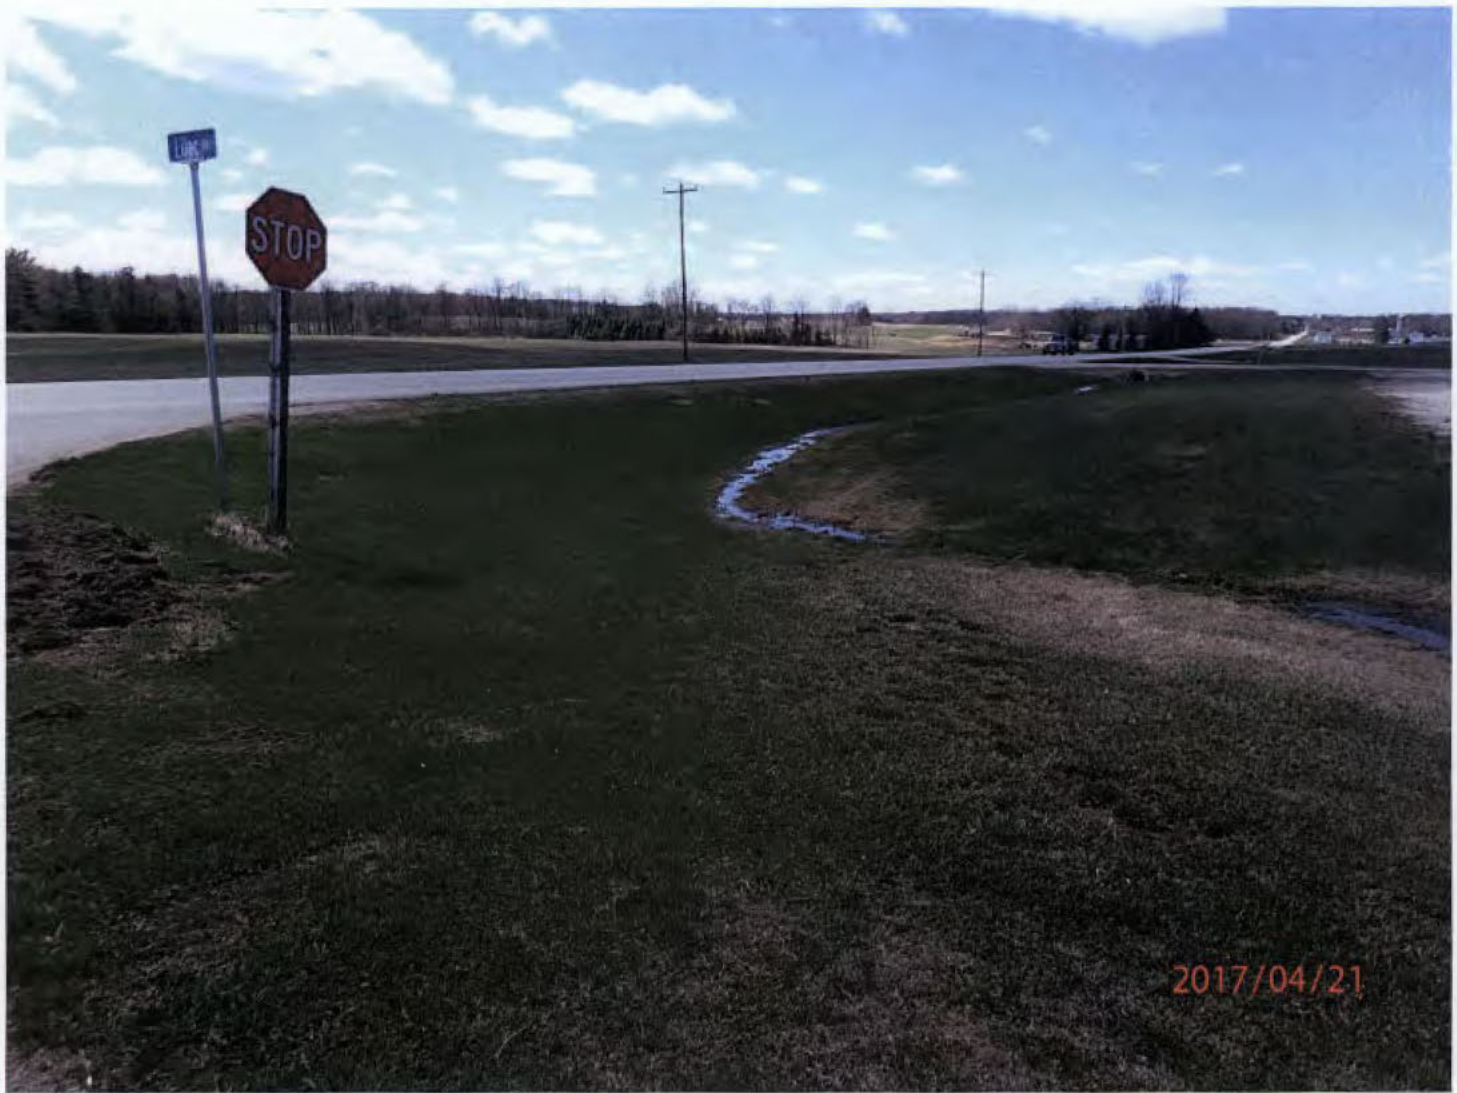
Photo: P4210125

Description: EPA observed the feed and surface water (process wastewater) that discharged off of the east side of the silage pad into the roadside ditch west of Lilac Lane. The process wastewater flowed south around the bend into the roadside ditch on the north side of County Road F.

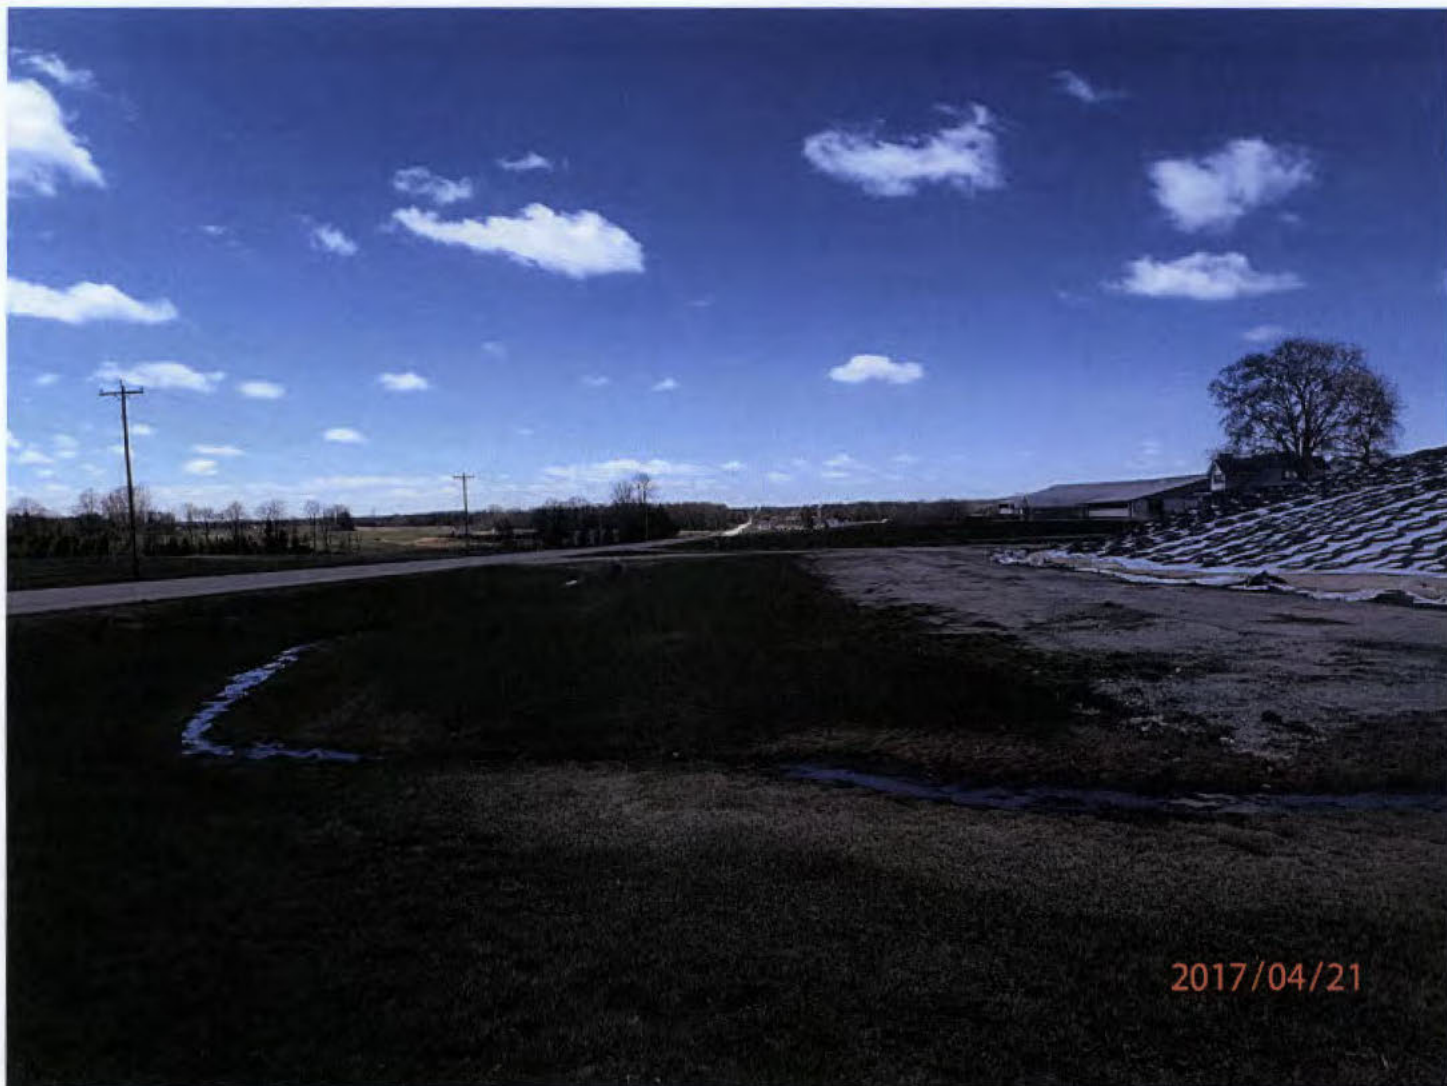
Photo: P4210126

Description: EPA observed the feed and surface water (process wastewater) that discharged off of the east side of the silage pad into the roadside ditch west of Lilac Lane. The process wastewater flowed south around the bend into the roadside ditch on the north side of County Road F.

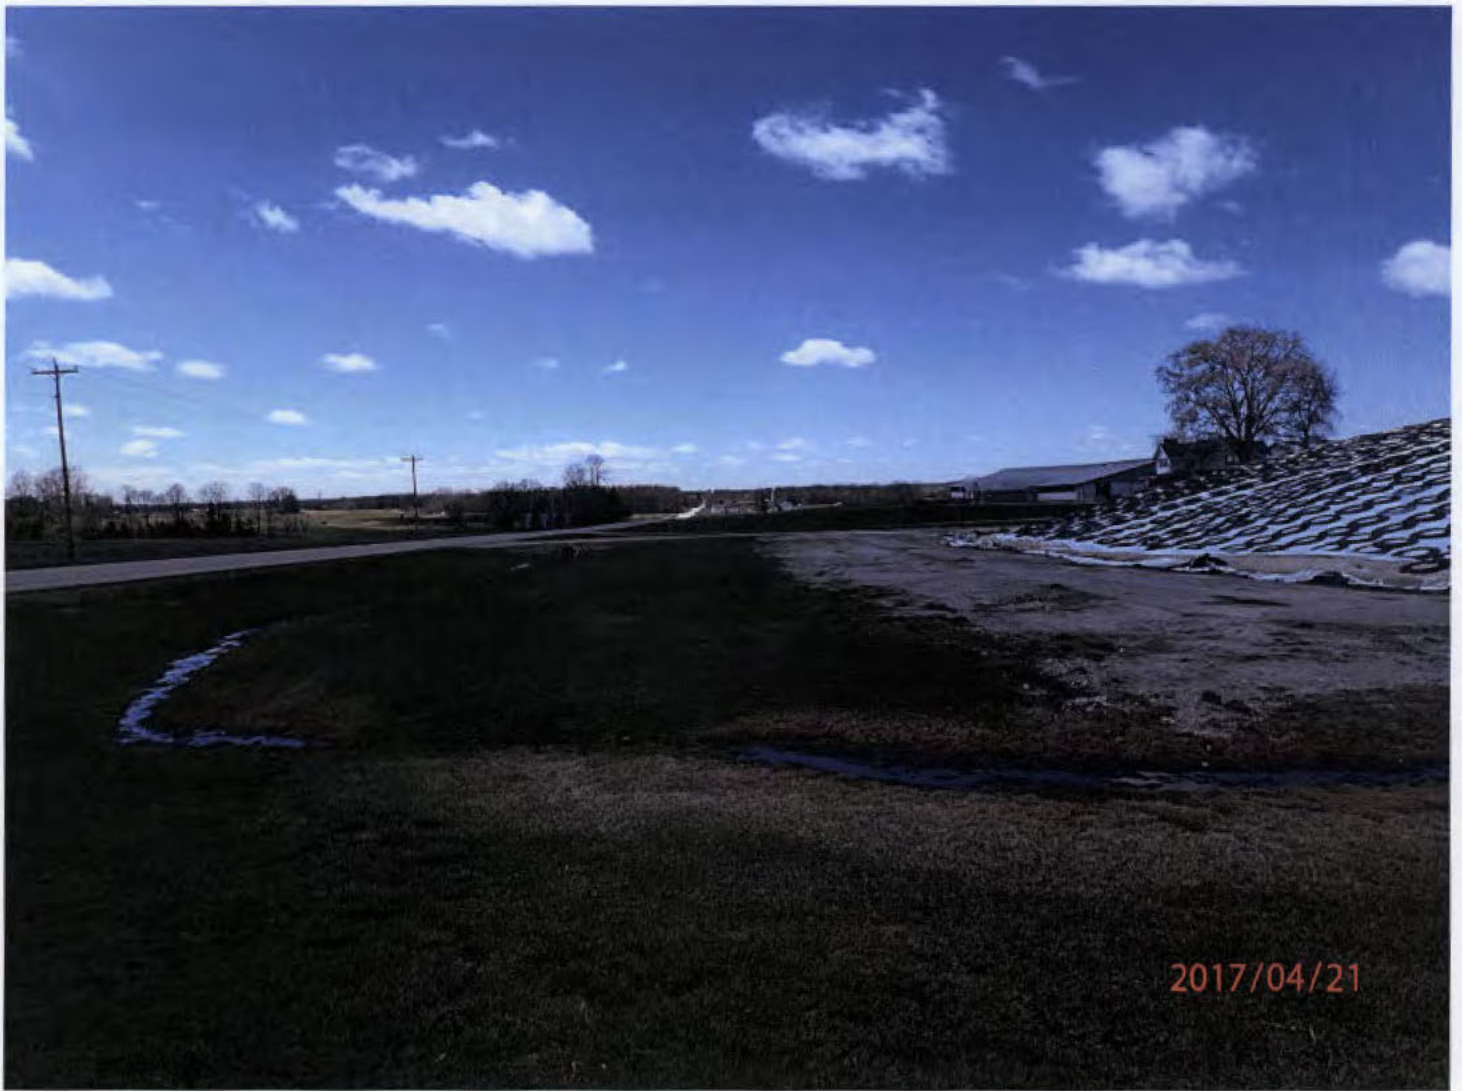
Photo: P4210127

Description: EPA observed the feed and surface water (process wastewater) that discharged off of the east side of the silage pad into the roadside ditch west of Lilac Lane. The process wastewater flowed south around the bend into the roadside ditch on the north side of County Road F.

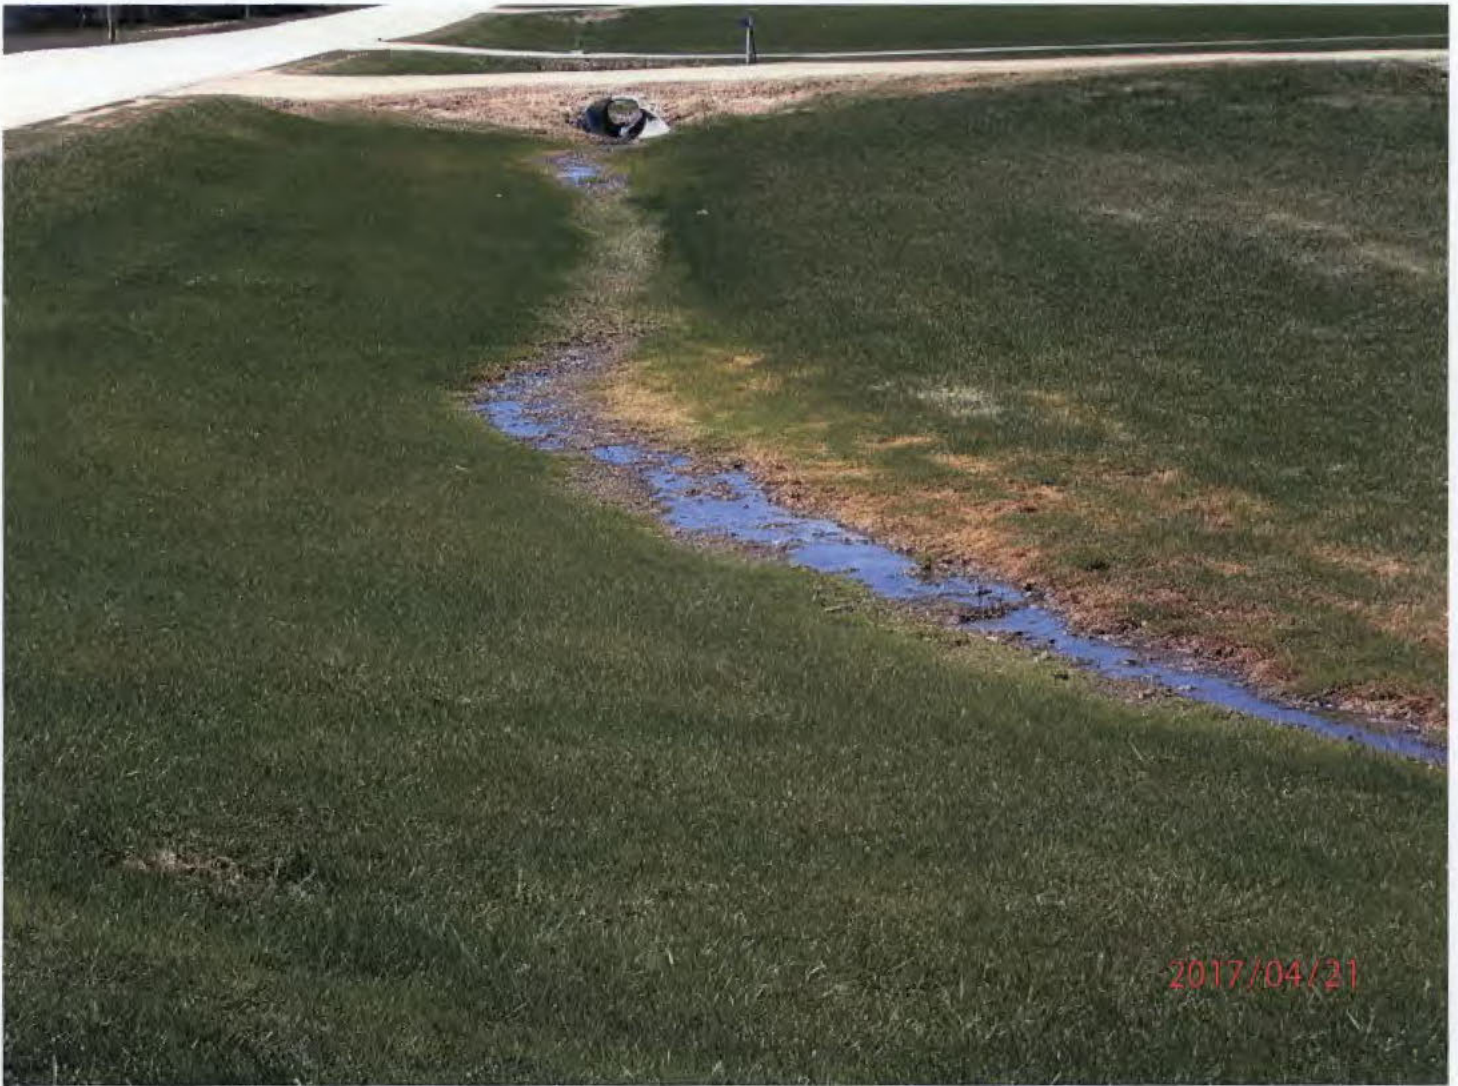
Photo: P4210128

Description: EPA observed the continued flow of process wastewater south in the roadside ditch west side of Lilac Lane into the roadside ditch on the north side of County Road F as it flowed west and through the culvert under the 1st driveway west of Lilac Lane to the silage pad.

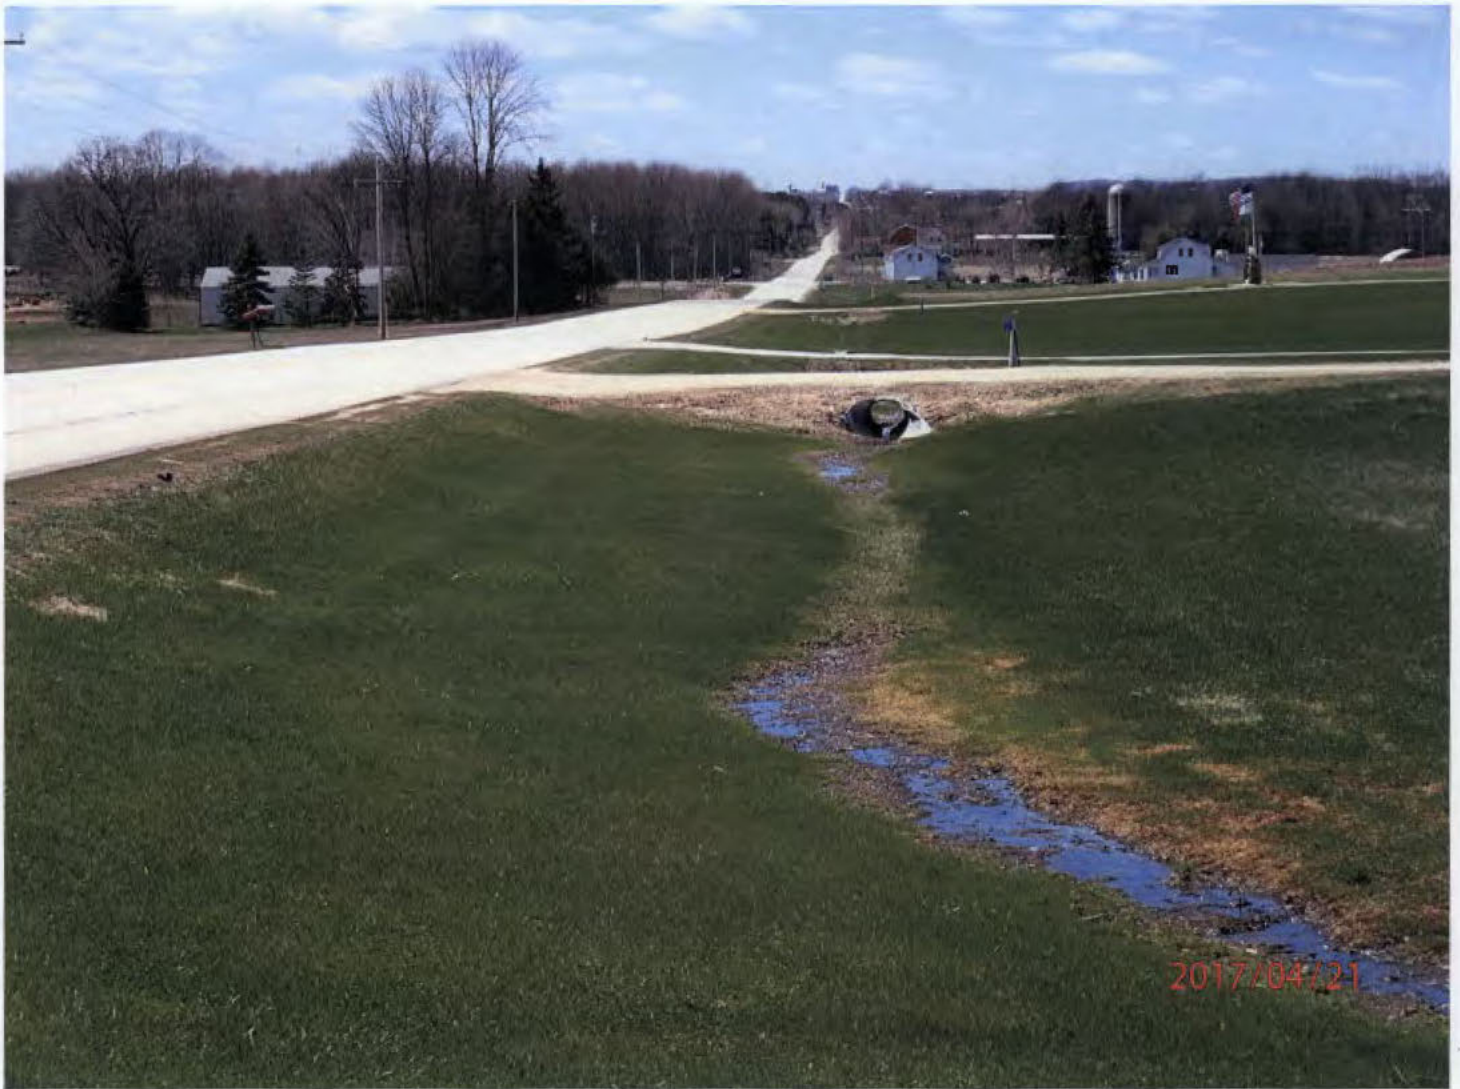
Photo: P4210129

Description: EPA observed the continued flow of process wastewater south in the roadside ditch west side of Lilac Lane into the roadside ditch on the north side of County Road F as it flowed west and through the culvert under the 1st driveway west of Lilac Lane to the silage pad.

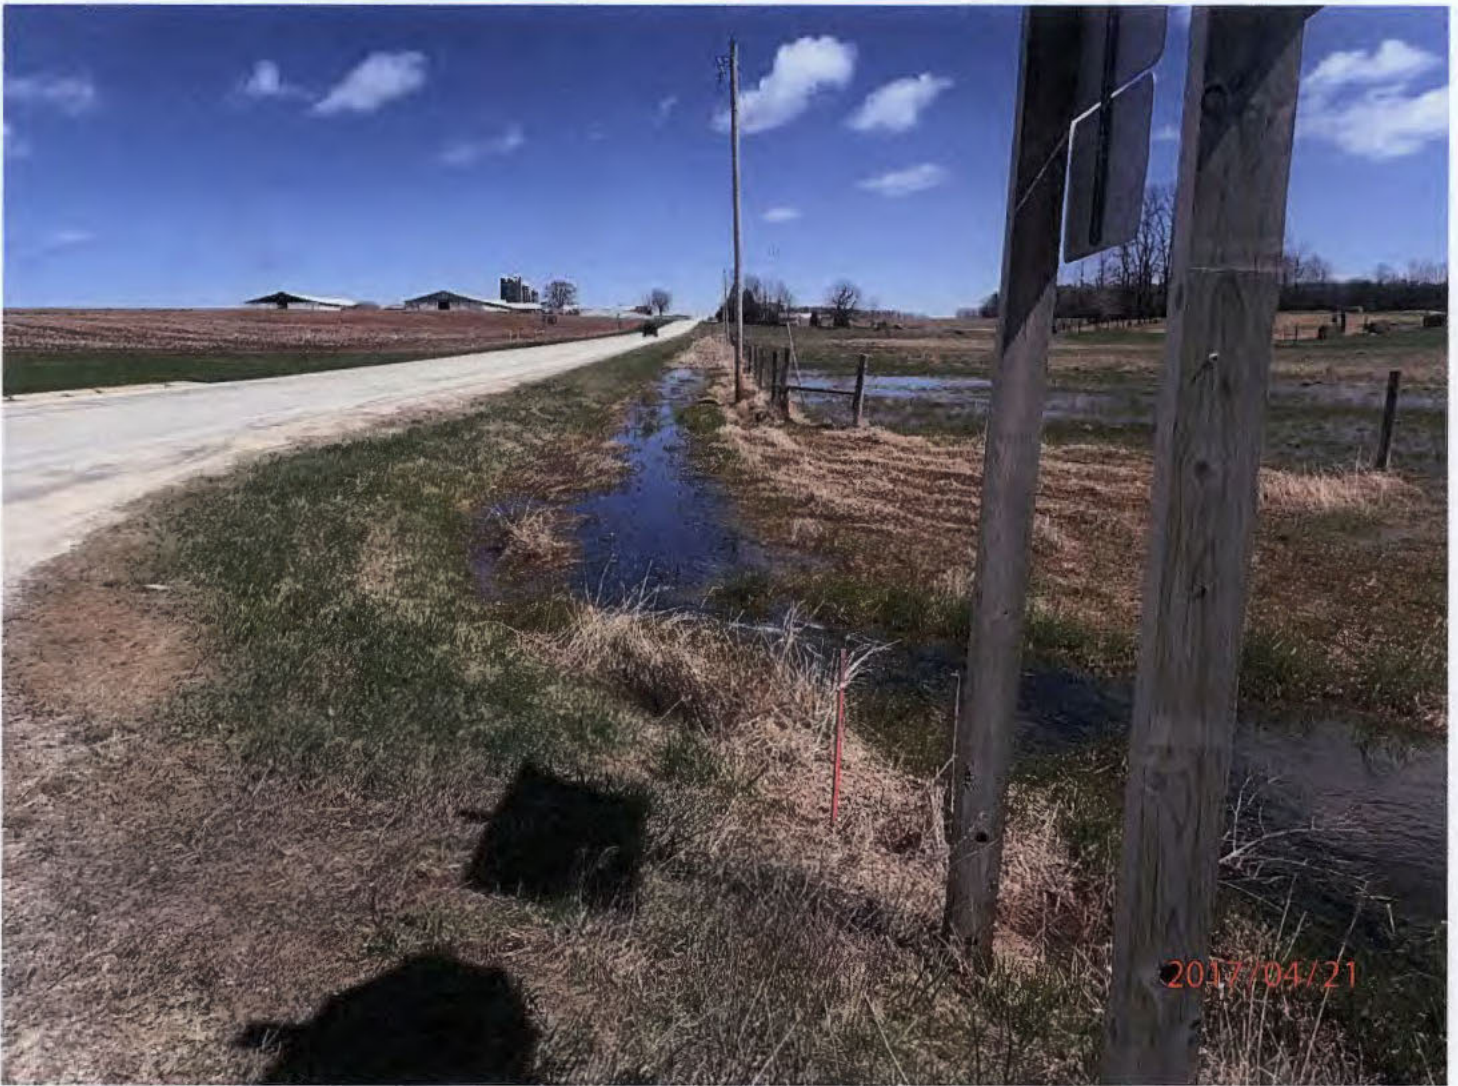
Photo: P4210130

Description: EPA observed that there was continued flow west in the roadside along the south side of County Road F at the location of the tile outlet (WDNR showed EPA the location) continued to flow west.

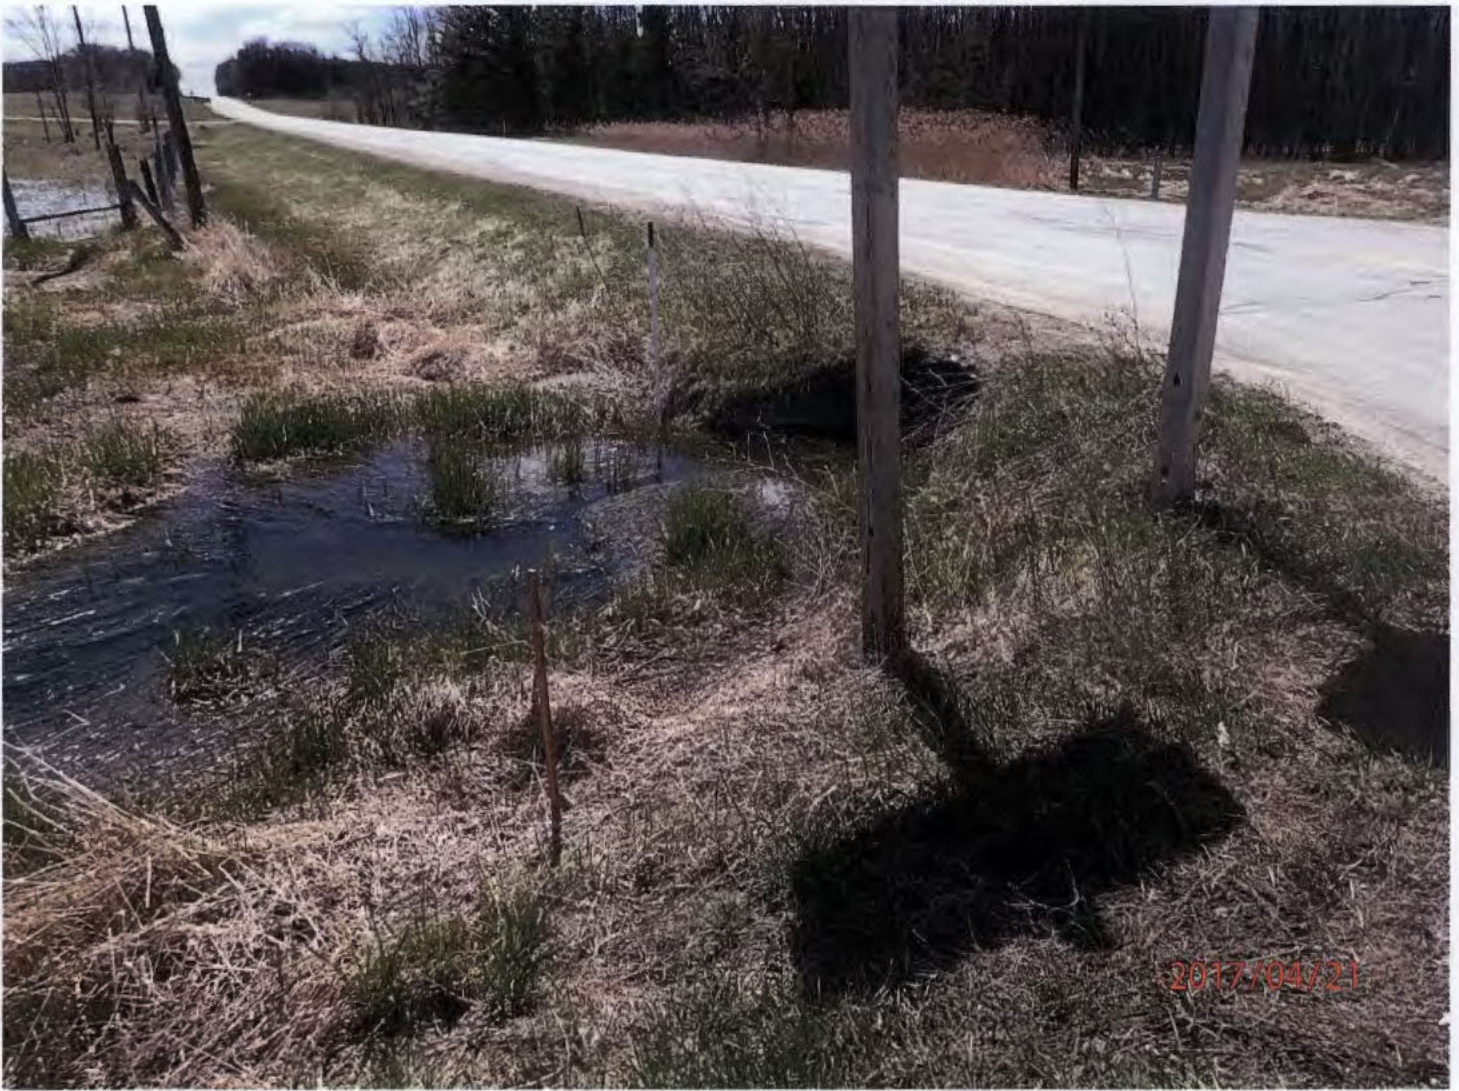
Photo: P4210131

Description: EPA observed that the flow from the tile outlet flows west through the culvert under County Road B flowing west.

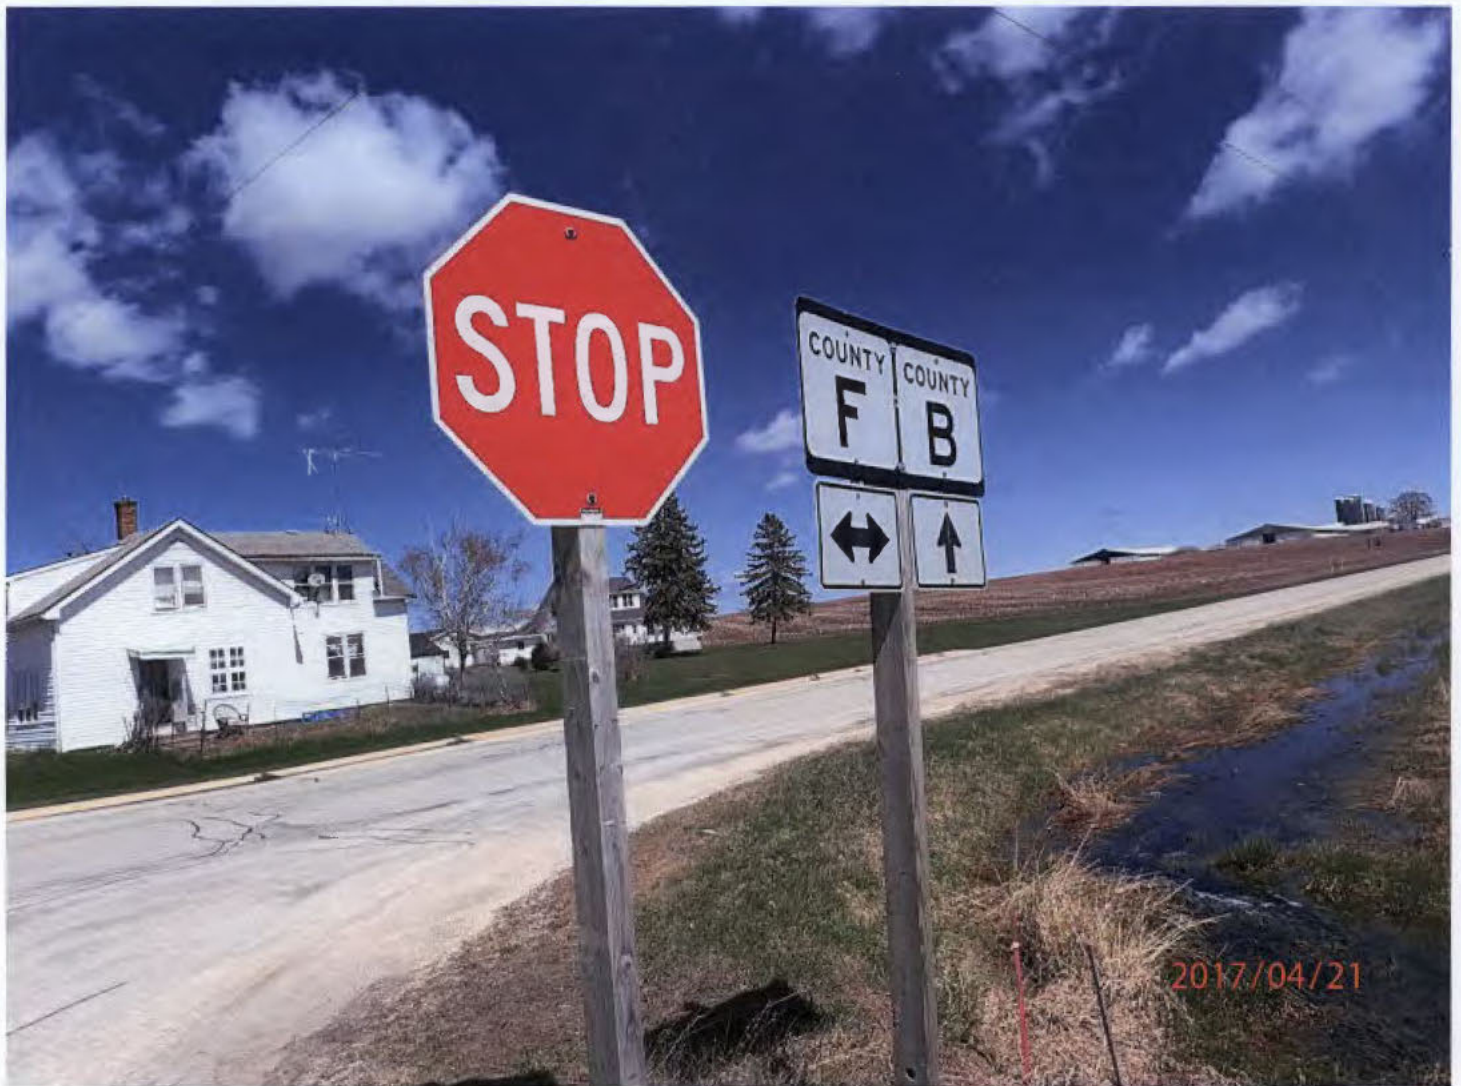
Photo: P4210132

Description: EPA was documenting location of where EPA observed the flow in the roadside ditch on south side of County Road F continued to flow through the culvert under County Road B.

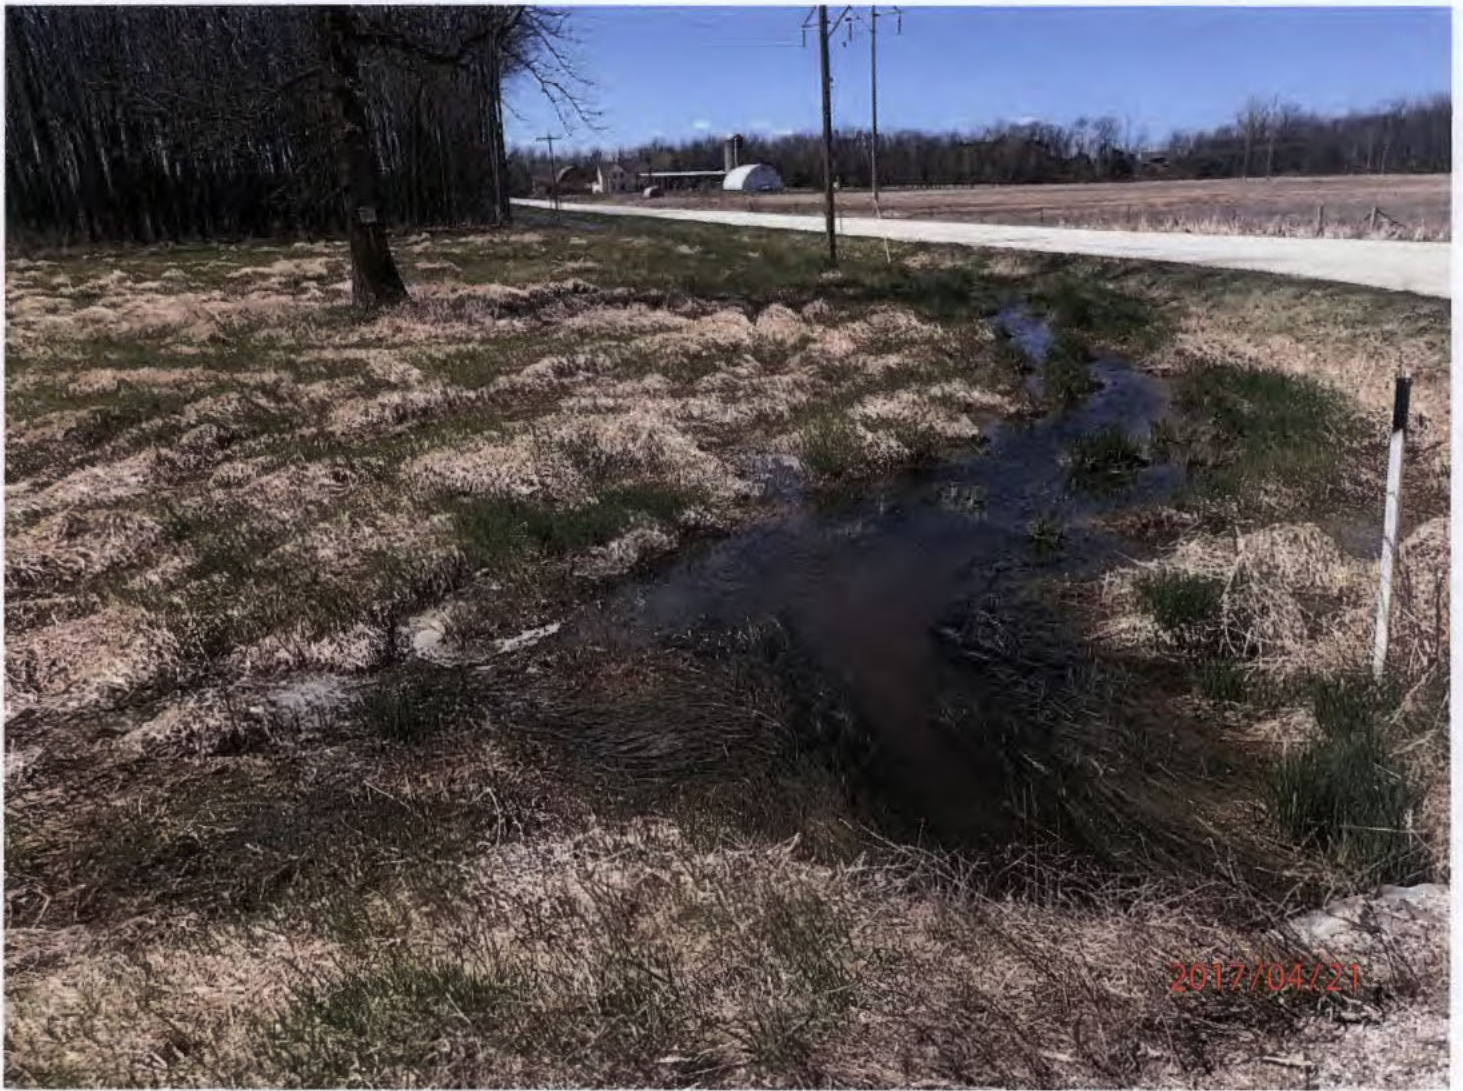
Photo: P4210133

Description: EPA observed the flow from the tile outlet through the culvert outlet on west side of County Road B which continued to flow in the roadside ditch along south side of County Road F.
